# TECHNICAL SERVICE BULLETIN

**BULLETIN NUMBER: DOBJ/DOBK – 022 REISSUE ★**

**LANIER – IM C2000/IM C2500**

**SUBJECT: TROUBLESHOOTING: SC860 THRU 865, 869, 870, 872, 873, 874, 876**

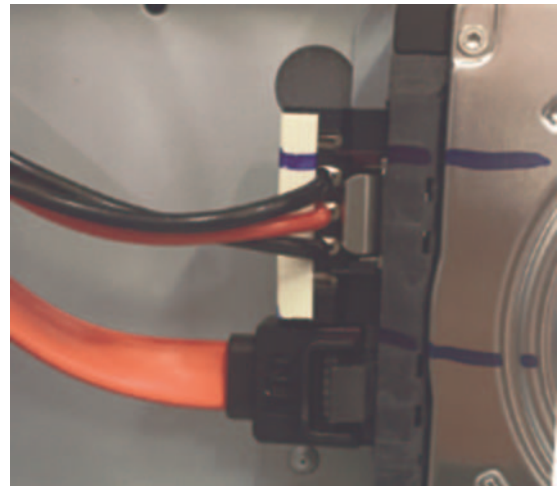
The HDD Cable provided from the vendor  
(P/N: D2415250: Cable: HDD: SATA:210) is defective.

1. Replace the HDD cable when SC8XX occurs.
2. If the symptom still occurs, replace the HDD or other parts (see Service Manual for procedure).

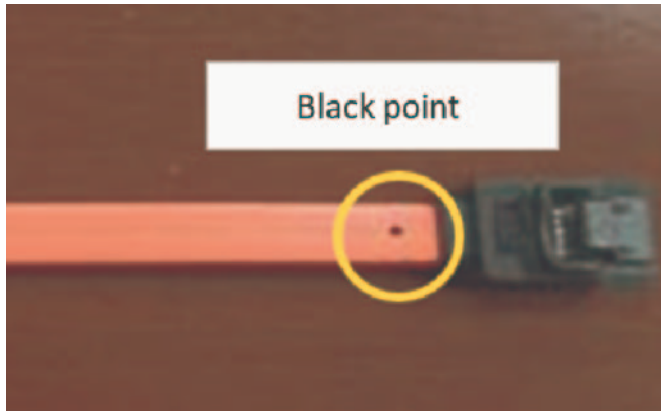
- ★ The Black Dot (Point) as shown in the photo below, indicates the new style cable.

The HDD Cable has been modified since July 2019 production.
