A 900.00 Firmware Error Results From a Damaged Scanner Cable

Document ID:SO8533

Lexmark CX820 Lexmark CX825 Lexmark CX827
Lexmark CX860 Lexmark XC8155 Lexmark XC8160

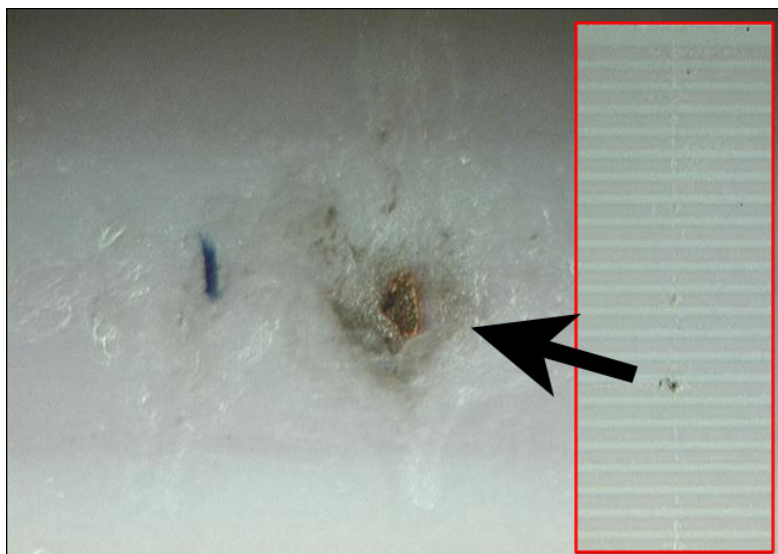
Illustration

A damaged **Flat Flex Cable (FFC)** results in **900.00 firmware errors** related to scanner functions. The most common error posted for this issue looks similar to:

"900.00 Firmware Error, comm Scanmgr.main, reason hydra killed by SIGABRT."

NOTE: This cable originates at the controller card's **J1** header and terminates at the flatbed CCDM. It is where this cable passes through the steel frame of the flatbed where the damage occurs.

Apply **tape** to the affected area of the FFC **or replace** the **FFC**.

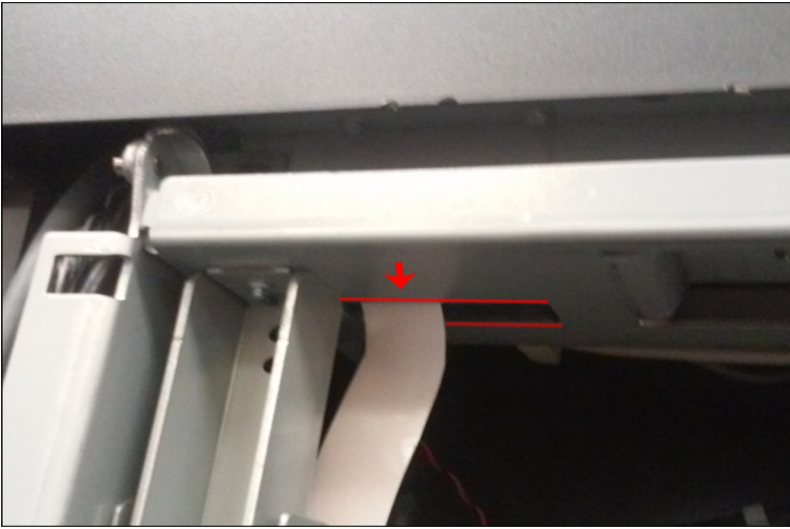
Step	Action
1	Remove the cover above door B .
2	Locate the area of damage; this is where the scanner's FFC passes through the steel frame .

3	Apply two layers of electrical tape to the top edge of the frame opening , specifically where the FFC makes contact with frame .
4	Apply one layer of tape on the FFC where cable passes through the frame .
5 Parts	If tape is not an option, or the issue persists, then replace the FFC . PN#: 41X0274 - Flat Flex Cable
