Mpc3004ex (DOAC) DEV UNIT

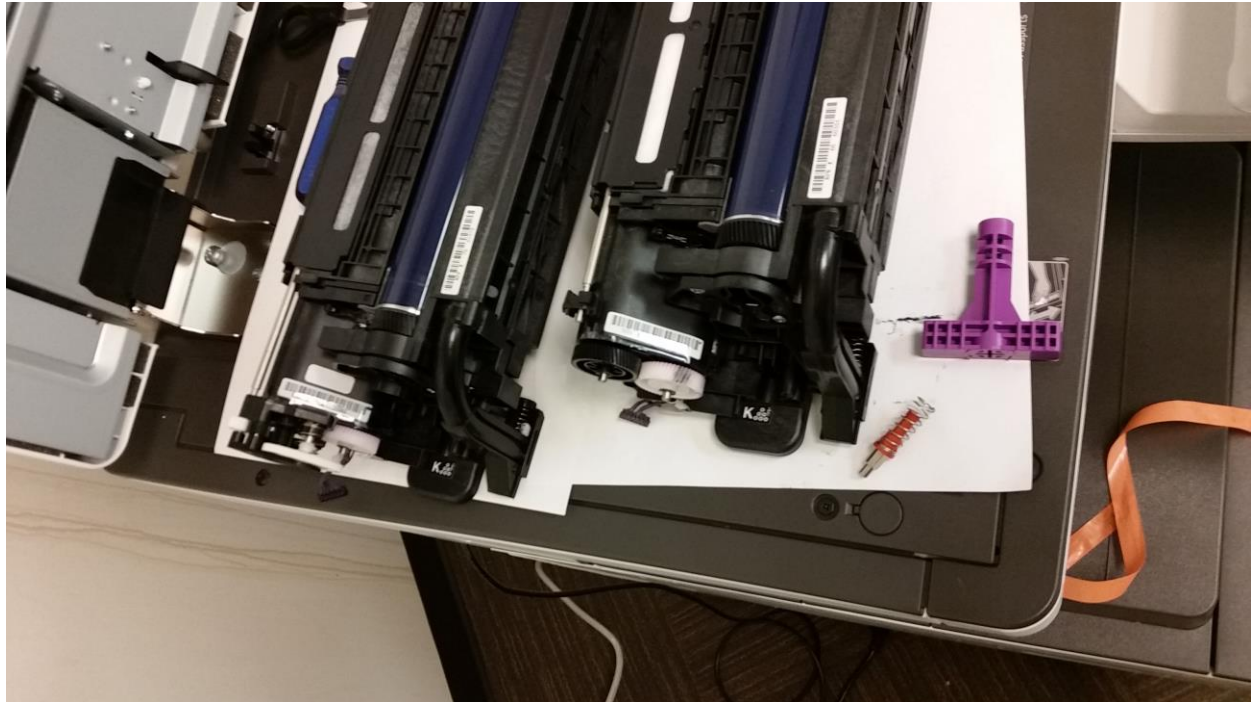
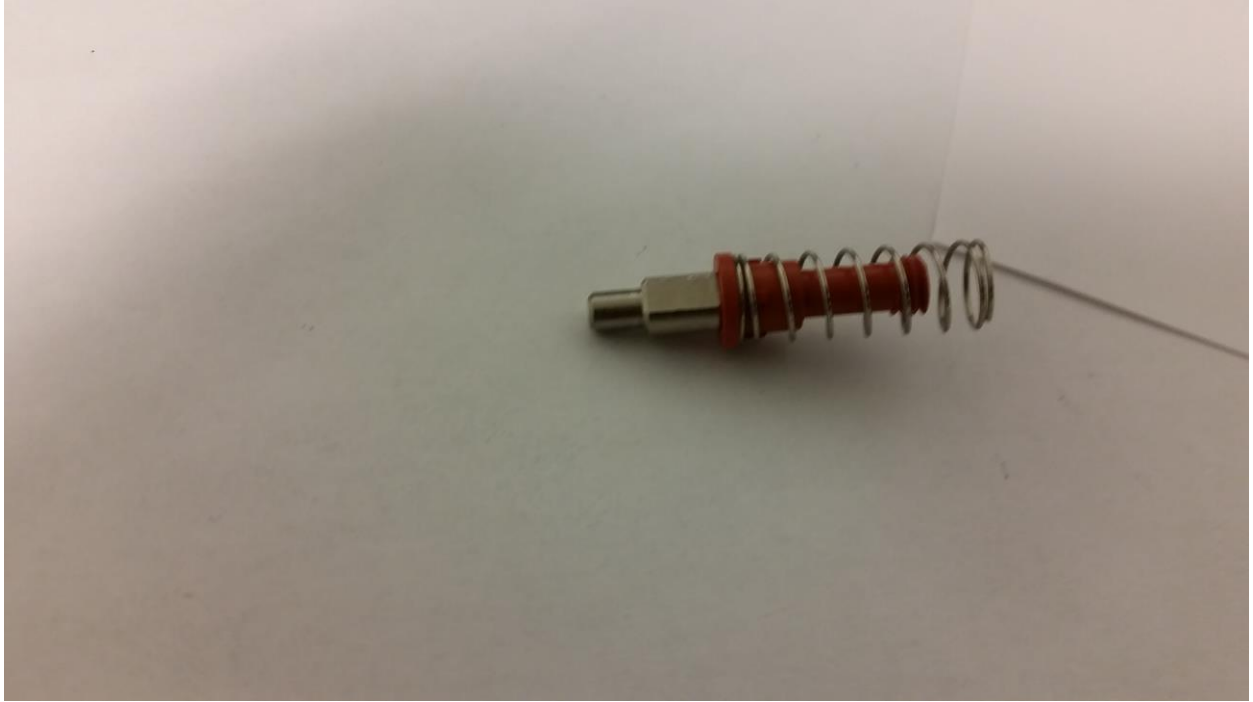
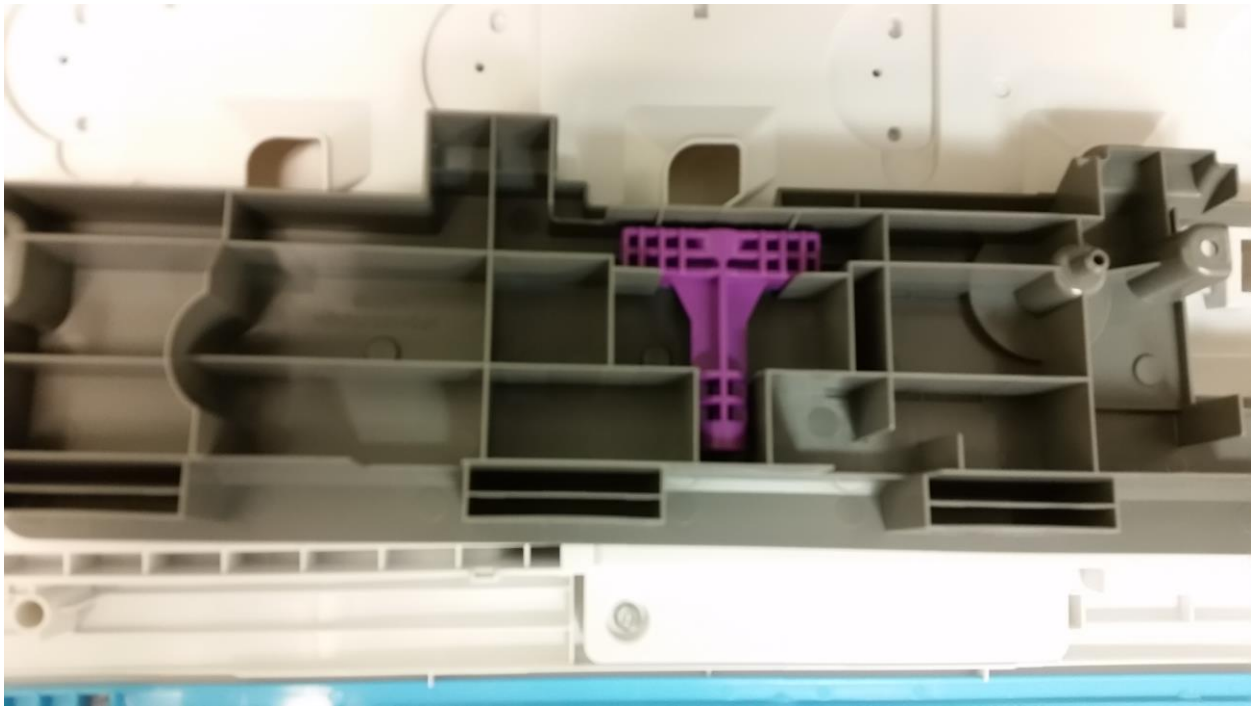
Mpc3004ex (DOAC), the dev unit has had a design change...**no tech bulletin!** The old unit has a gear cluster no longer found on the new unit. Its purpose is for internally removing the dev seal, much like the older pull-tape seal. The service manual does not mention this for this model except to state the procedure not being needed. There is a tool found on the inside of the transfer belt cover used to rotate a shaft (with orange rubber bushing) until the shaft tip with bushing is release for removal. Pictures attached.

If you are not aware of this procedure or design change it is very confusing. I found this design change info in the parts catalog folder named "Design Change List" and can find no other reference to the change or the procedure for any of the above. It is just a list with no links to anything else, just a new number. The parts catalog shows two different PCDU part numbers, both label "A" with no explanation.
