Potential problem with the newest versions of the Ricoh 8300.
Problem Intermittent SC563

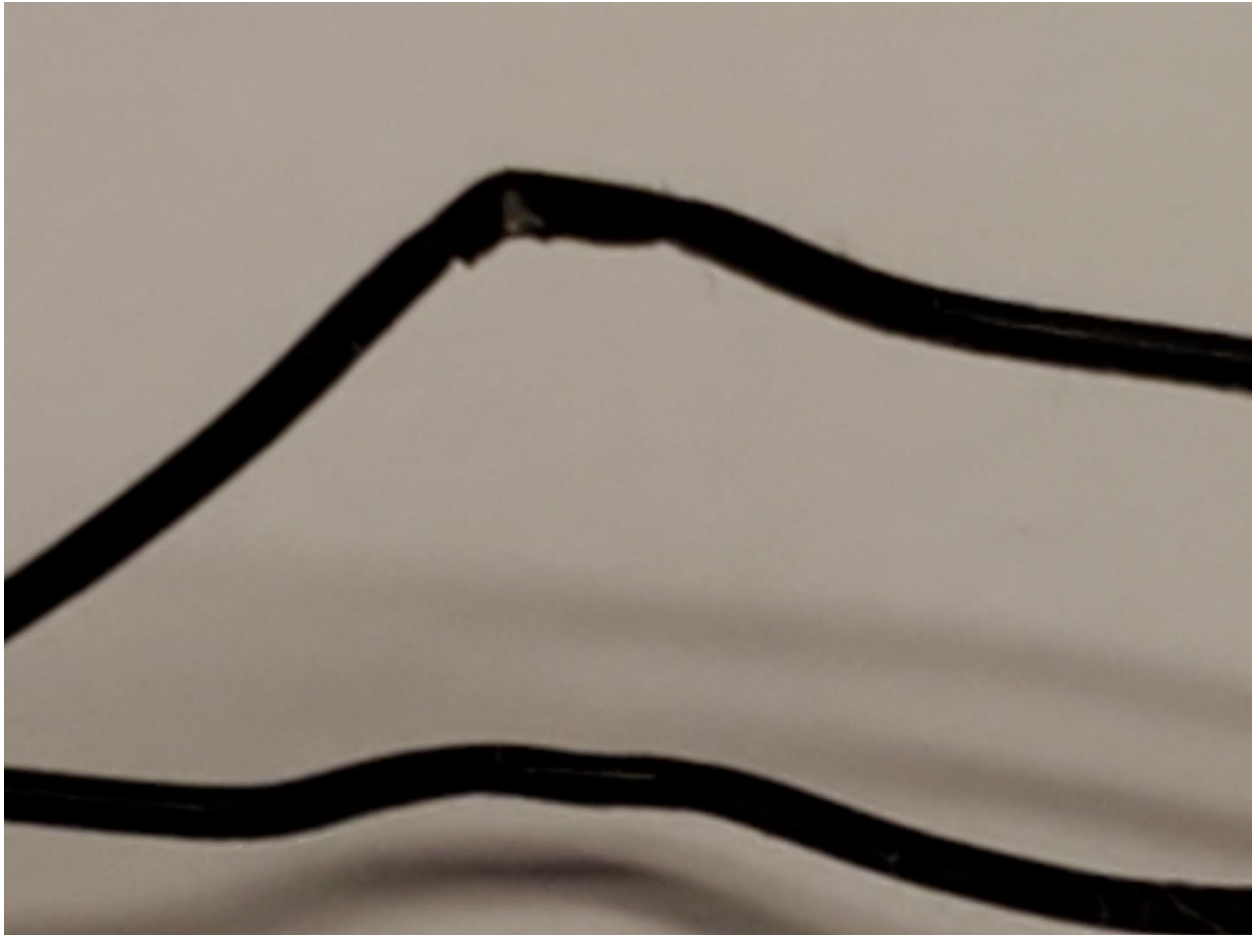
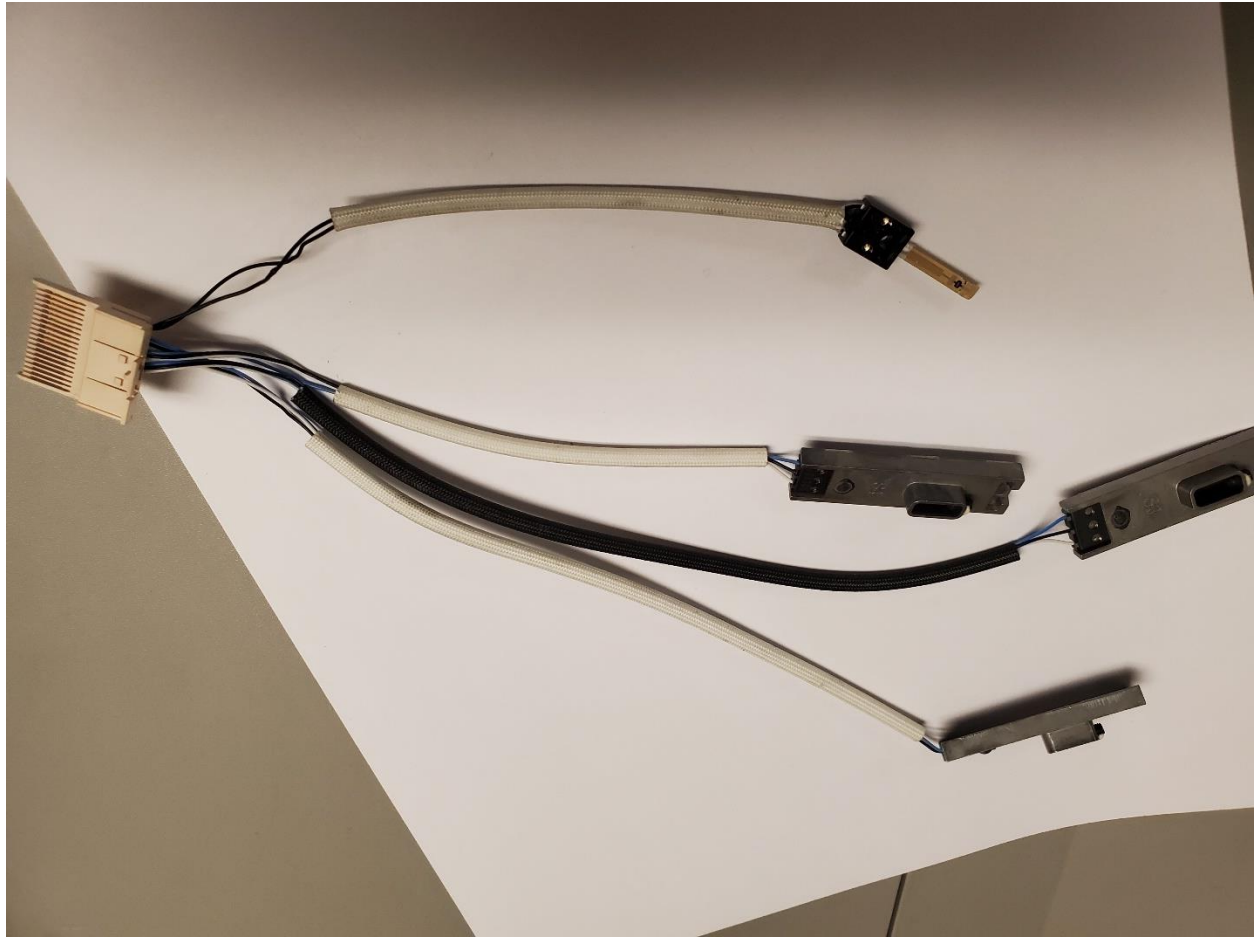
Found that the wire ties are too tight on thermistor wiring breaking the wire (See Pics)
Part # to correct the issue is D1795381
This part is the harness that includes thermistor and heat sensors for Upper fuser unit...
