## RU-513, jam code 75-42 or 75-43

ID: **KBA00039440**

## Field mod to RU-513 to Correct Jamming on Long Continuous Runs

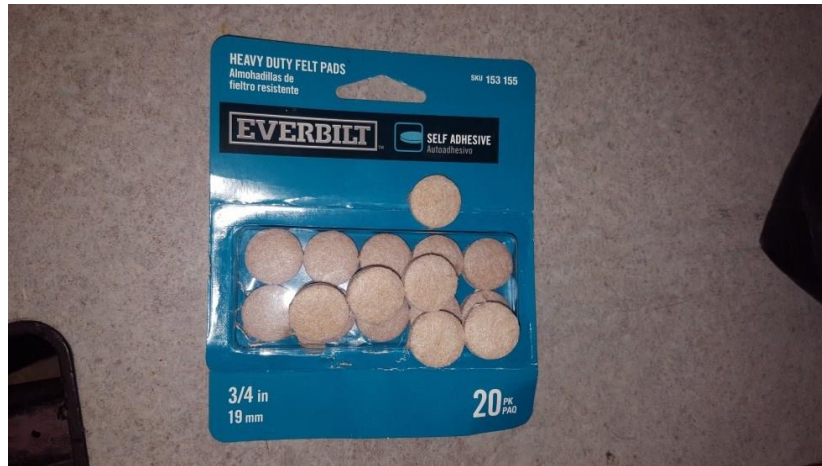
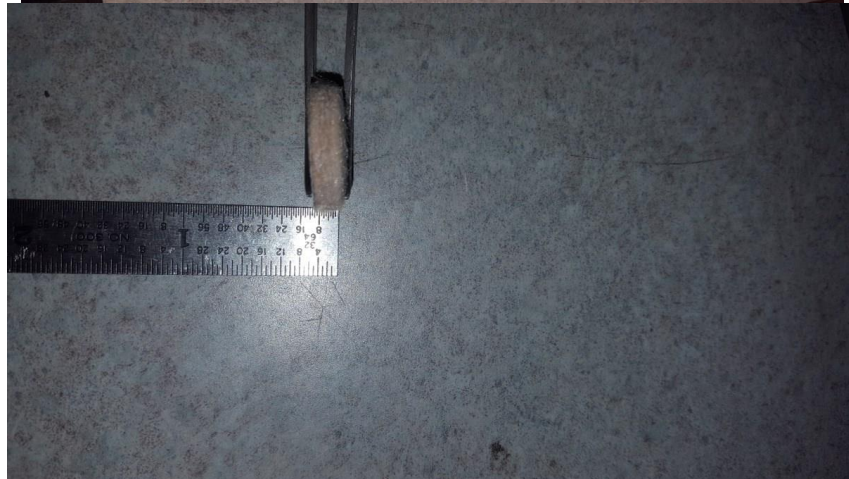
Adhesive felt tabs (1 per RU-513):

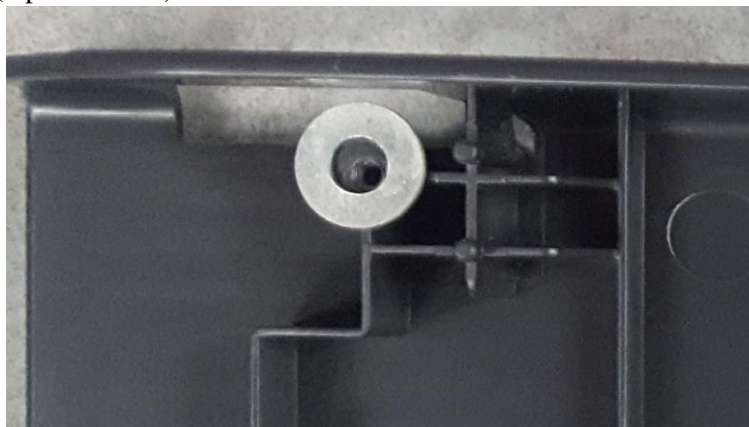
Washers as pictured (2 per RU-513):
