# TECHNICAL BULLETIN

Bulletin # 11244

Subject: Rainbow-Effect Scans

# 3<sup>rd</sup> MIRROR ADJUSTMENT PROCEDURE (CHROMATIC ABERRATION) bizhub C458, C558, C658

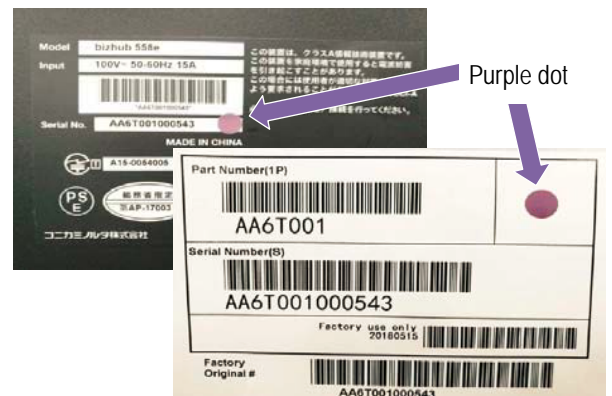
These machines can be readily identified by a purple dot on the shipping carton data table and the machine serial number plate.
