# TECHNICAL SERVICE BULLETIN

**BULLETIN NUMBER: D223/D224/D225 – 018 REISSUE**

**LANIER – MP 6503SP/MP 7503SP/MP 9003SP**

**SUBJECT: SMART OPERATION PANEL TROUBLESHOOTING**

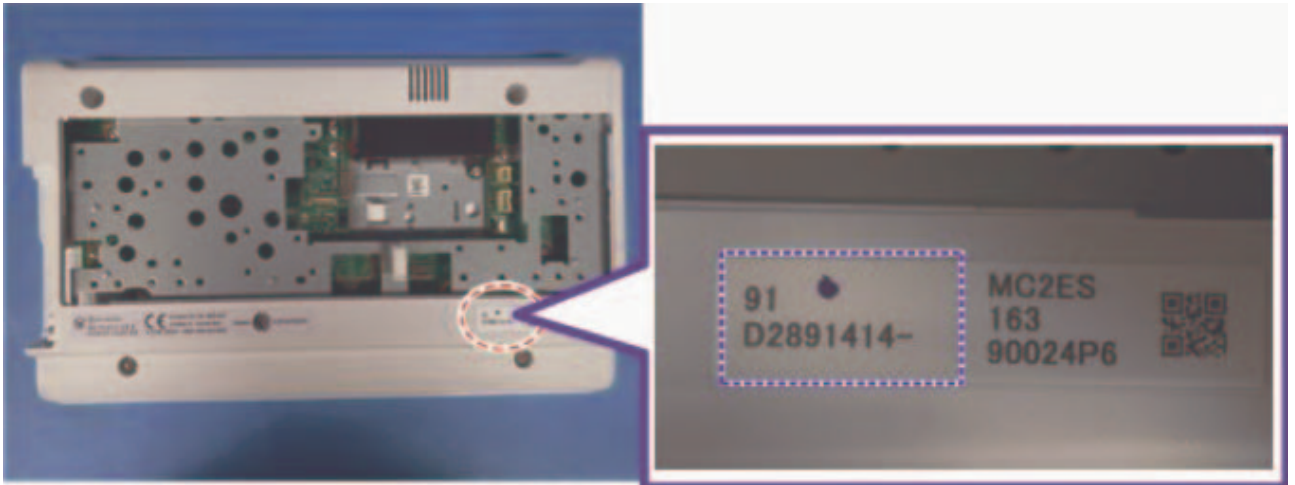
## HOW TO DISTINGUISH THE TYPE OF ELECTRICAL BOARD CONSTRUCTION:

PCB construction type is distinguishable from the prefix (4 digits) of SOP parts number shown on SOP back side. In the case of "D196", "D223", "D241", "D261", "D263", "M0AJ" or "D296", it is 2 Board Type. Others are 1 Board Type.
